WORKING PAPER N° IDB-WP-01778

Effectiveness of Crossing Structures for Wildlife on Two Roads Associated with Biological Corridors in Costa Rica

Inter-American Development Bank
Climate Change Solutions Division

February 2026

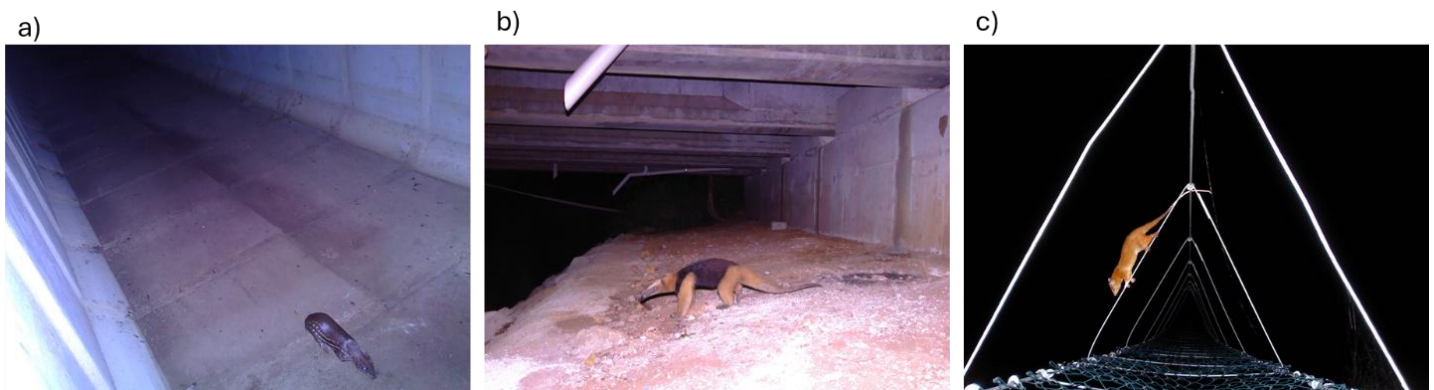
Fig. 3. Examples of a) box culvert, b) bridge adapted with ledges for wildlife, and c) canopy bridge installed on Route 1.

The National Route 1, section Limonal to Cañas, is in Guanacaste, between Abangares and Cañas. It has a total length of 20.2 km, with four paved lanes, two in each direction, and a maximum speed of 80 km/h. Its width can vary between approximately 25 m and 60 m, divided by a concrete median barrier or New Jersey barrier in some sections. It includes bus bays, shoulders, gutters, turnarounds, and other infrastructure elements. It has six bridges, which have been adapted with dry ledges for wildlife (without fencing), four box culverts that do not have dry ledges or fences to direct wildlife, and six canopy bridges (Figure 3). Underpasses are comprised of 2x2m or

2.7x2.7m box culverts (varying 29-52 m in length). Canopy bridges are 60-cm wide with 27 to 34 m of length, installed at approximately 8 to 10-m height. Route 1 is located within the Arenal-Tempisque Conservation Area and crosses the Howler Monkey Biological Corridor and six important rivers. It presents three life zones: Tropical Humid Forest, Humid Forest transitioning to Dry, and Premontane Humid Forest transitioning to Basal (Bolaños, Watson & Tosi, 2005). Land cover and uses present in the area are agriculture, teak plantations, patches of secondary and riparian forests, cattle pasture and urban settlements.
