Goodbye Barriers!

A Guide to Design More Accessible Spaces

Infrastructure and
Energy Sector

TECHNICAL
NOTE Nº
IDB-TN-01752

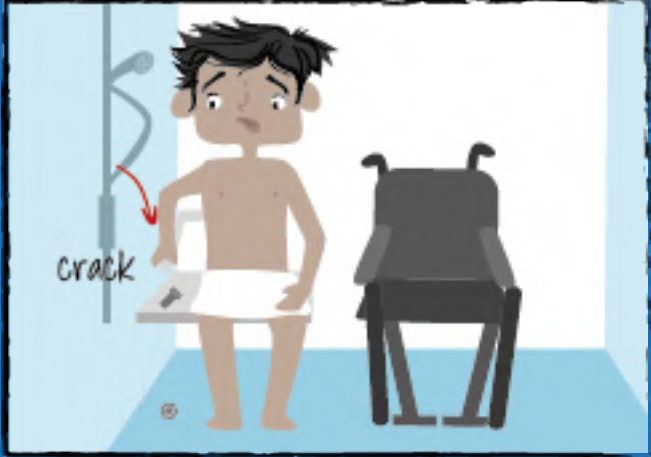
If the grab bars are not well installed or do not support the indicated weight, Felipe may fall.

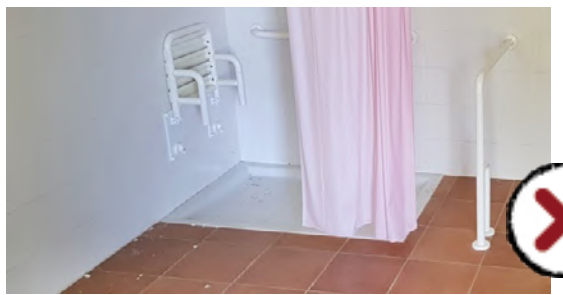
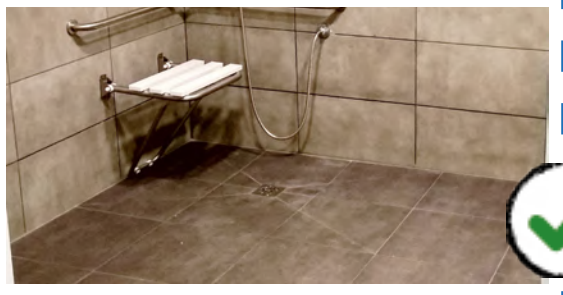
UNE-ISO 21542. Page 86 (Image 45)

- The excellent preparation of the ground where the pavement sits is essential to maintain a firm and levelled pavement. Therefore, the installation instructions recommended by the manufacturer and the provisions of the corresponding project must be followed, avoiding sloping areas, or areas without adequate leveling, etc.

- It must be verified that the pavement pieces do not show visible irregularities (broken, defective parts, etc.).
- It should be verified that no protrusions or gaps between floor pieces are left.
- Special care must be taken when executing drainage slopes, which must not exceed 2%.
- Sinks and drains must be perfectly leveled with the floor.

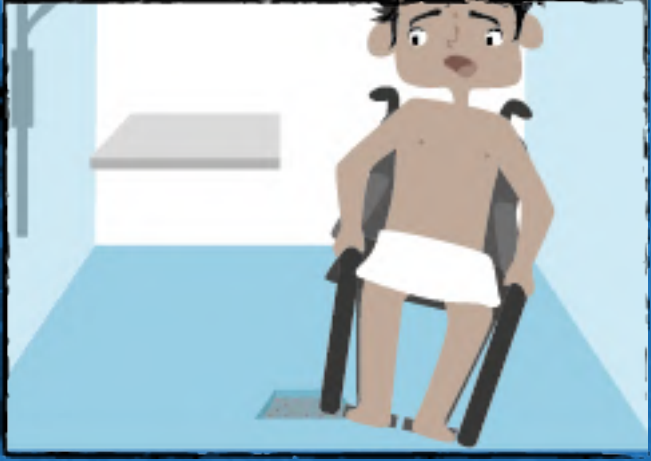
If the shower drain is not properly levelled with the floor, Felipe may fall.

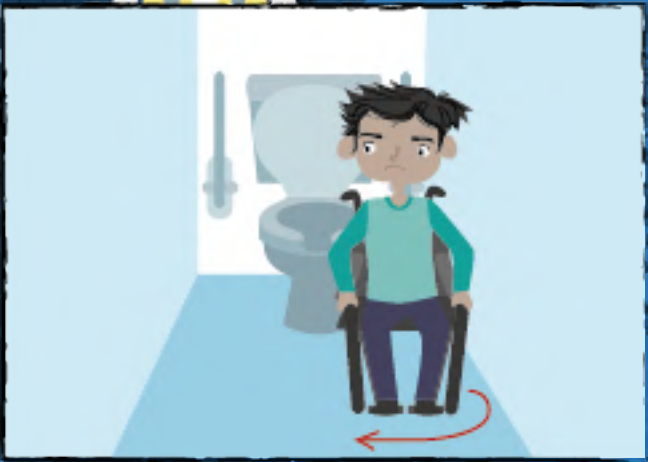
If the toilet space is not adequate, Felipe cannot make the turn or be near enough the toilet to be able to make the transfer.

For the location of the toilet, the separation of the grab bars must be taken into account, so the distance between the toilet and the vertical wall on the side where the transfer is not carried out will be conditioned by the width of the toilet and the separation between the grab bars (centered on the axis of the toilet and separated from each other at a distance between 60 and 70 cm).

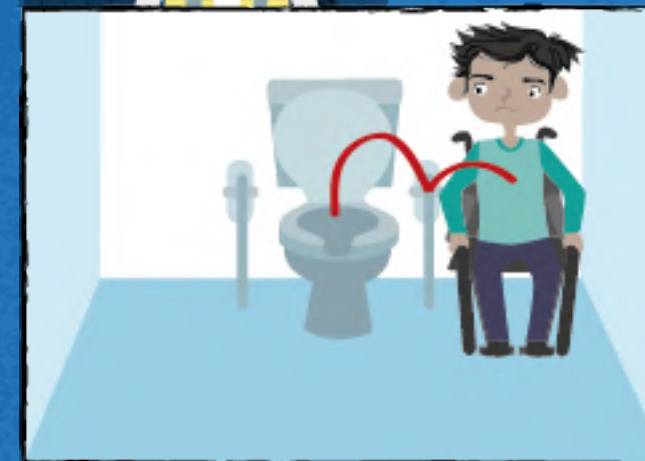
If the grab bars are not foldable, Felipe cannot transfer from the chair to the toilet.

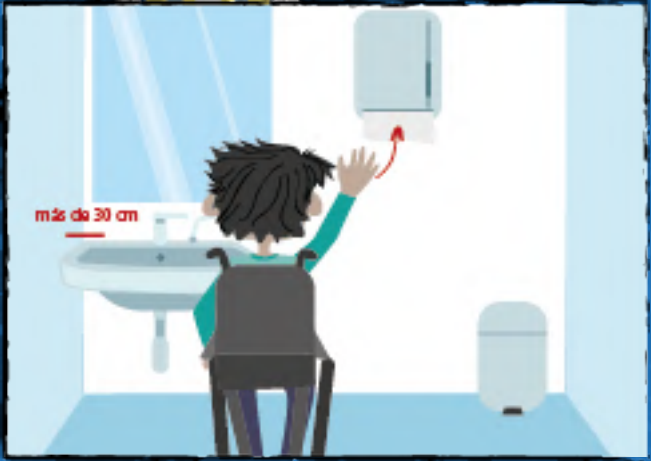
If the hand dryer is too high, Felipe cannot reach it.

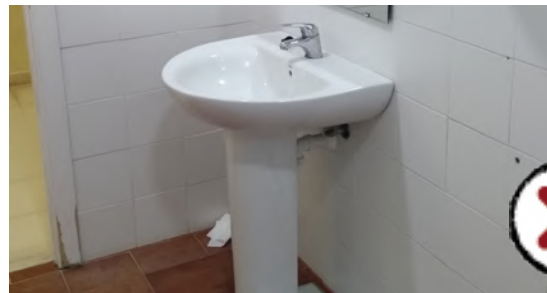
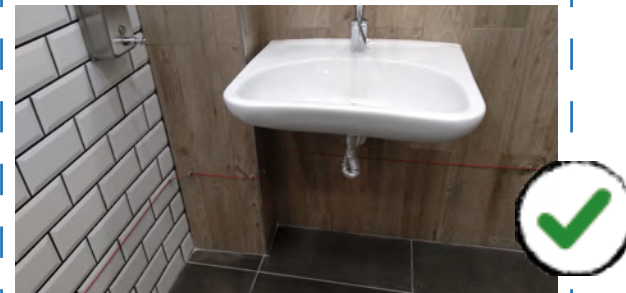
UNE-ISO 21542. Page 83 (Image 43)

- Inadequate height.
- Insufficient lower space for frontal approach.
- Existence of other elements (obstacles) that hinder frontal access to the sink.

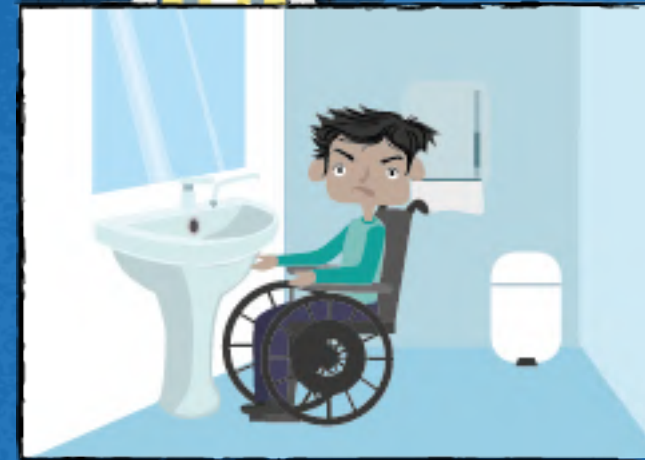
If the sink has a pedestal, Felipe cannot get close enough to use it.

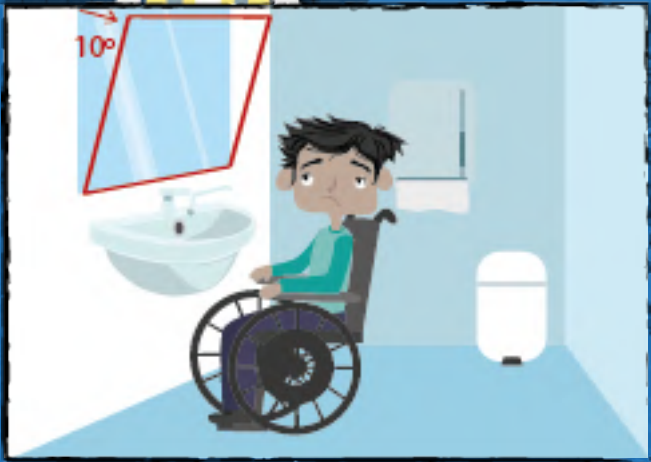
If the mirror does not have the necessary inclination, Felipe cannot see himself in it.

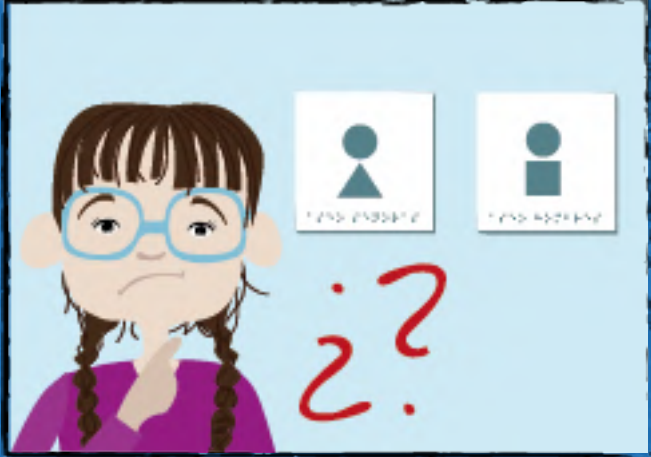
If the signaling of the toilet is not clear and easily recognizable, Paula cannot know which is the women's toilet.

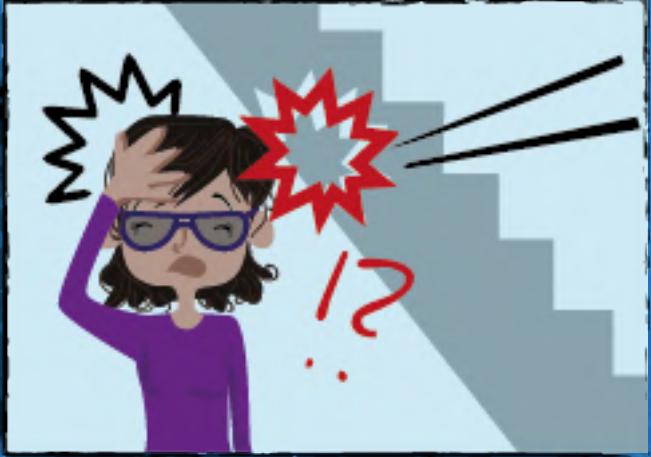
If the gaps under the stairs are not protected, Isabela can hurt herself.

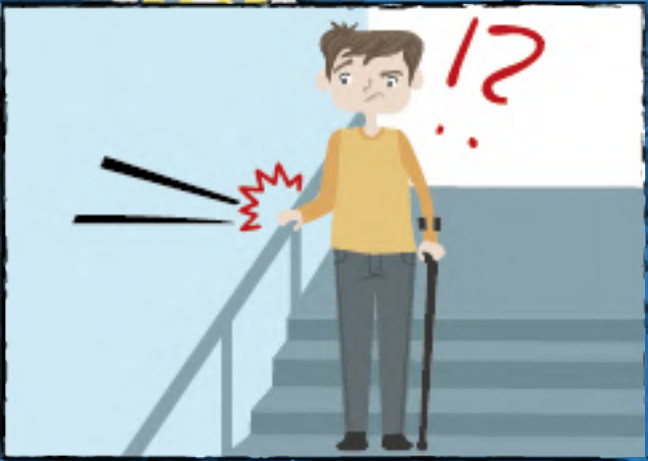
If the handrails do not have enough space to grip properly, or there are elements that prevent the hand from sliding along its entire path, Jorge may feel insecure when using them.

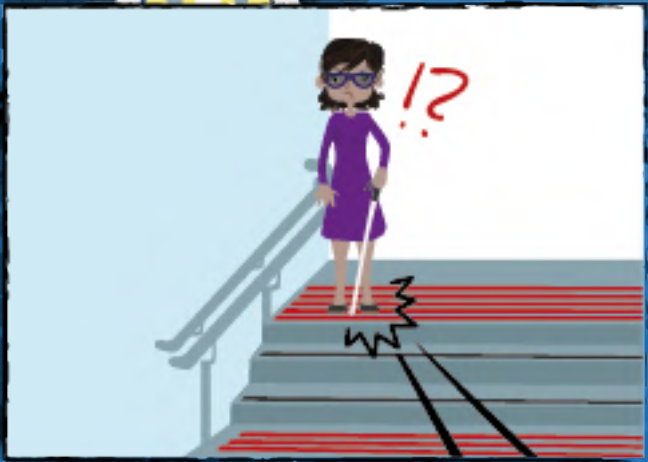
If the beginning and the end of the stairs do not have tactile-visual signaling, Isabela cannot locate it and may fall.

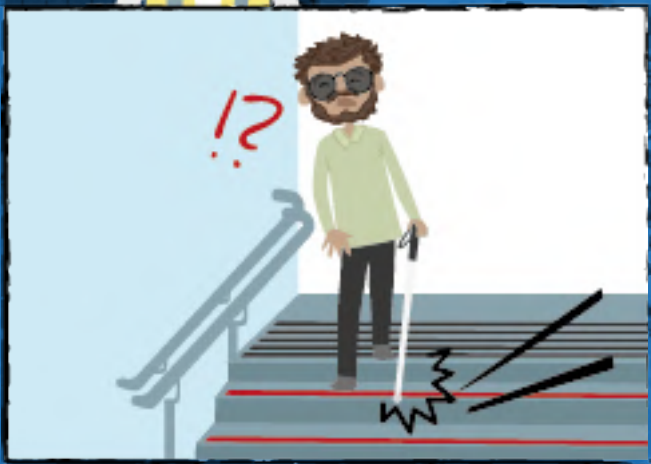
If the steps are not marked with different colors at the edges, Darek won't be able to properly find them and could fall.

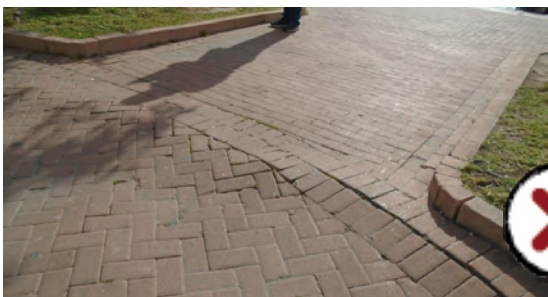
It must be verified that all the pieces of the pavement to be placed do not show visible irregularities (broken, defective parts, etc.).

No gaps or pojections larger than 3mm should be left between pieces. In addition, the separation joints on floor pieces must not exceed 20 mm.

The excellent preparation of the ground where the pavement sits is essential to maintain a firm and levelled pavement. Therefore, the installation instructions recommended by the manufacturer and the provisions of the corresponding project must be followed, avoiding sloping areas, or areas without adequate leveling, etc.

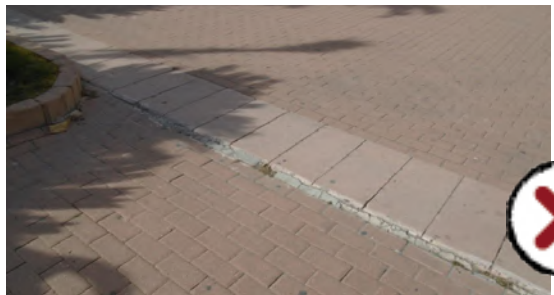
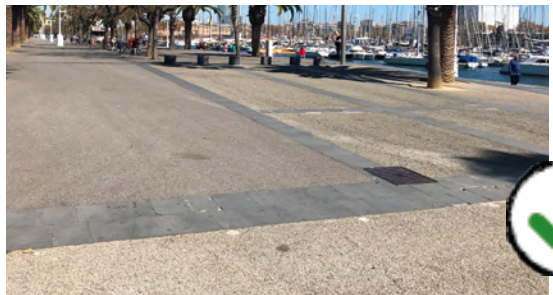
Expansion joints (with gaps larger than 20 mm) must be filled with specific material or covered with fixed elements (such as plates). Projections must be removed or, at least, generate inclined surfaces with slopes with less than 25% of inclination.

If there are discontinuities between pavements, Ana can trip and fall!

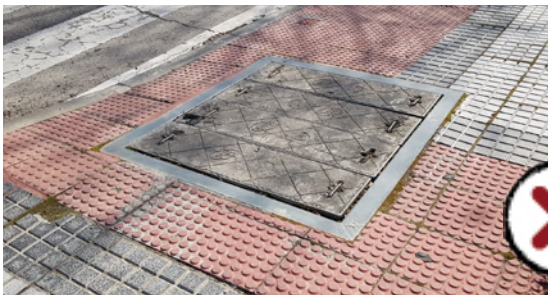
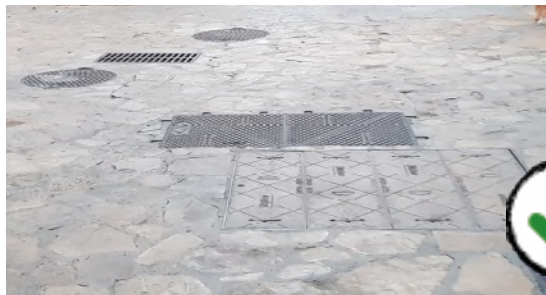
It must be perfectly levelled with the surrounding flooring.

When longitudinal voids form the grid lattice, they must be oriented transversely to the direction of the pedestrian itinerary.

If manholes and manhole covers are not aligned with the sidewalk surrounding it, Pedro's walker can get stuck and tip over.

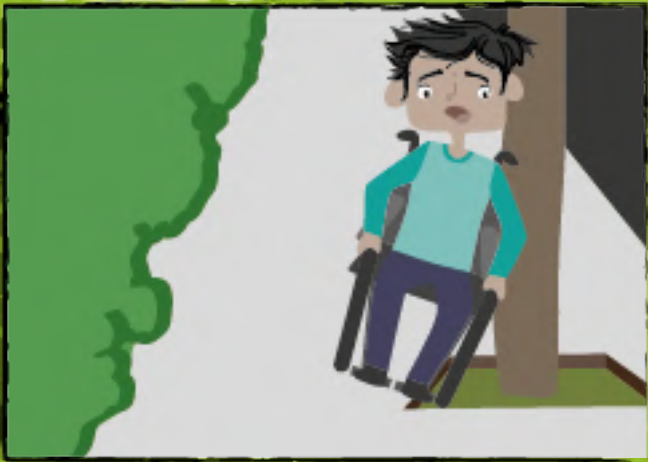
If the flowerbed is not well protected, Felipe's wheel can fall into the hole and tip over.

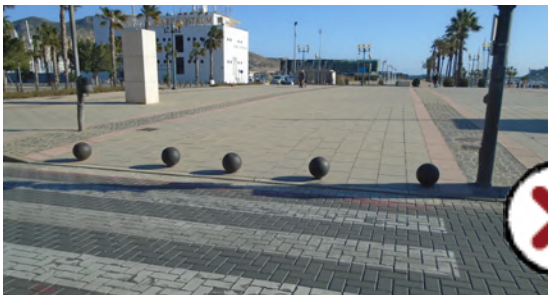
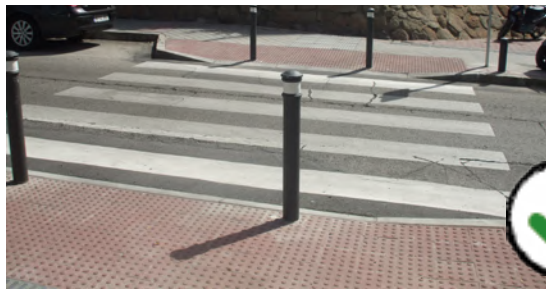
Good practices

On pedestrian itineraries, it should be located aligned to the sidewalk edge, without invading the pedestrian itinerary.

If these elements have pavement anchors, the plates must be flush with the pavement without protruding.

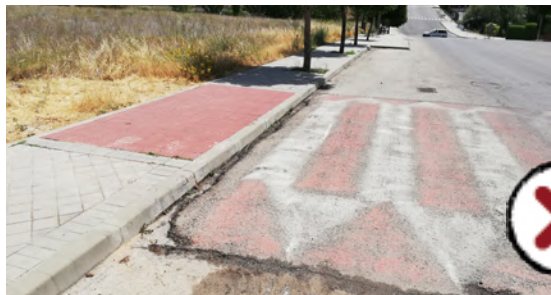
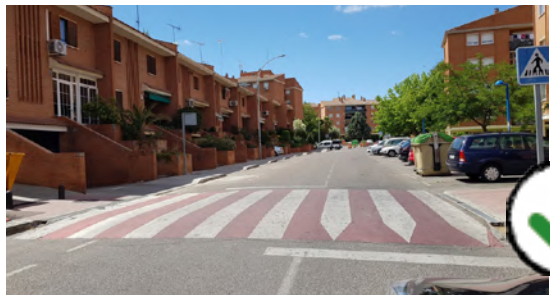
Good practices

- Incorrect execution of elevated crosswalks.
- Unevenness due to the inadequate encounter between the sidewalk and the surface of the elevated crosswalk.
- Sidewalk discontinuities and the surface of the raised crosswalk interrupting the flow of rainwater.

To allow the flow of rainwater, a through tube or a grid that ensures the leveling and continuity between the sidewalk and the surface of the raised crosswalk may be installed.

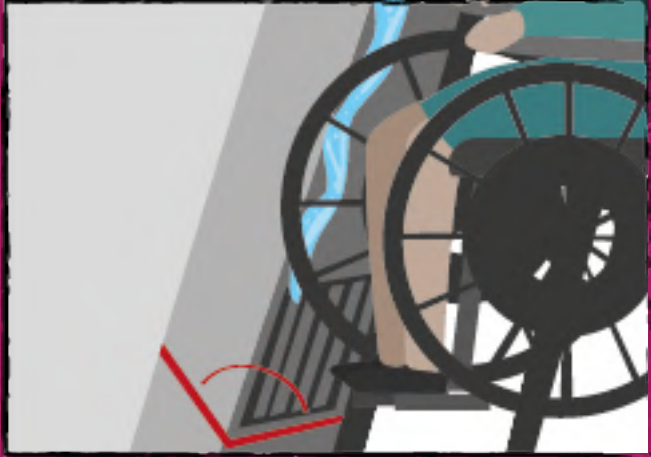
If the sidewalk and the surface of the crosswalk are not perfectly levelled, Lis cannot cross because the wheels of the chair can get stuck.

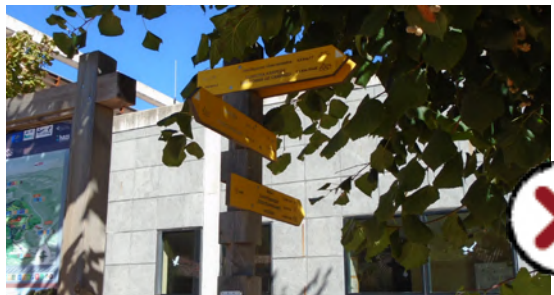
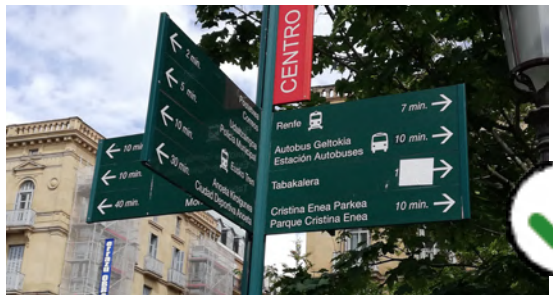
Good practices

The use of standardized pictograms is recommended to improve the understanding of the information.

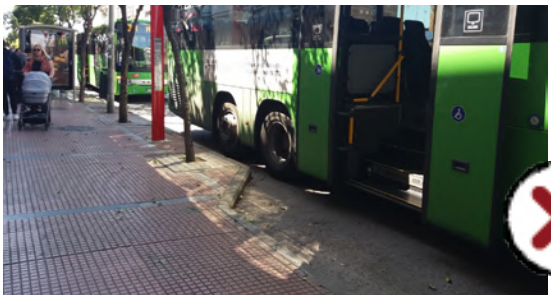
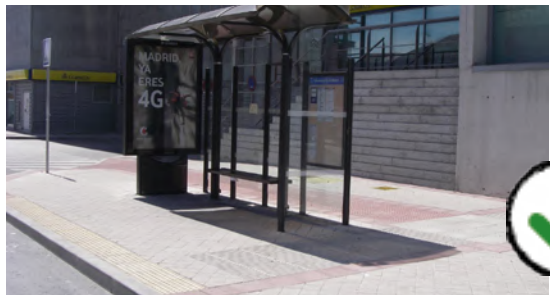
Good practices

Depending on the weather conditions, it may be necessary to install a waiting canopy, which must have seats with armrests and backrest and enough free space for a wheelchair user to wait under it and to maneuver.

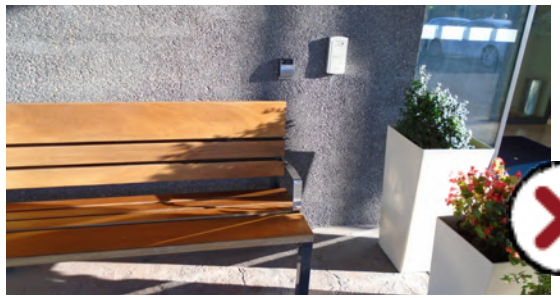
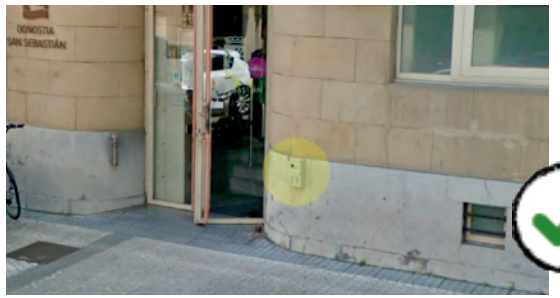
UNE-ISO 21542. Page 67

Mechanisms associated with doors, such as call box, doorbells, cardholders, etc., should be located at a height between 80 and 100 cm (preferably 90cm).

In addition, these should be located more than 60 cm apart from the corner (adjacent) to allow the approach. The approach space must be free of obstacles.

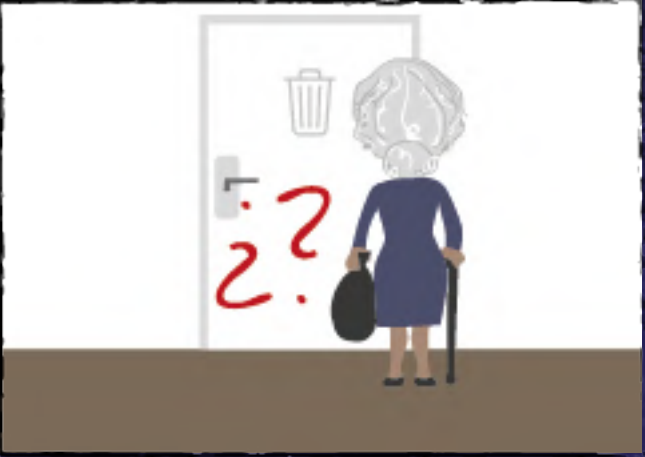
If the doors do not contrast with the walls through a different color, Ana cannot find the door to the garbage room.

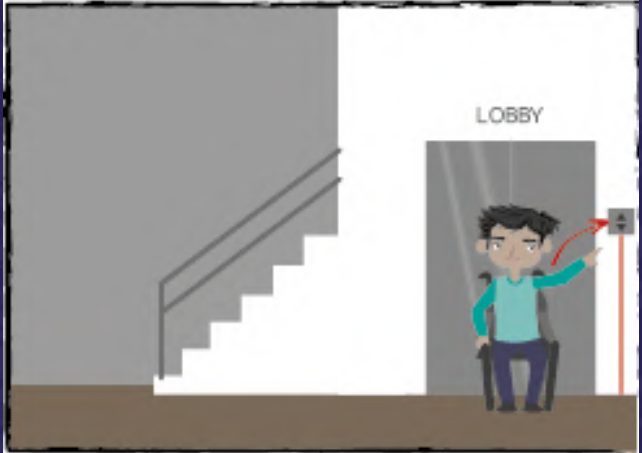
If the elevator panel is too high or too close to a corner Felipe cannot press the buttons to go up to his house.

The minimum distance between the external panel and any corner (if any) must be of 50 cm (recommended 60 cm), to allow the approach.

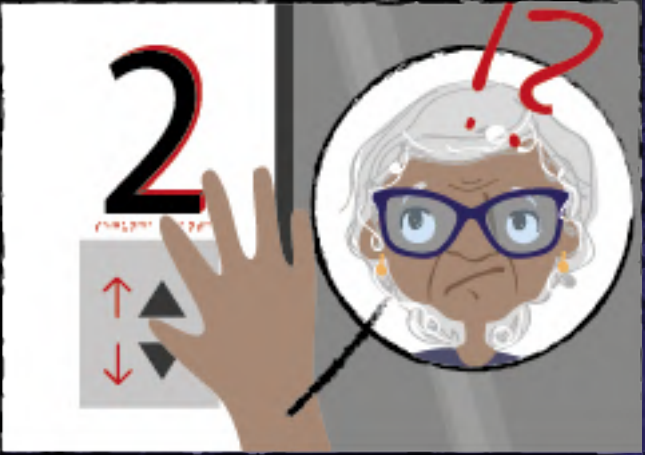
If the signage of the floor number is not well located or does not have Braille and high-relief, Ana cannot know on which floor she has gotten off the elevator.

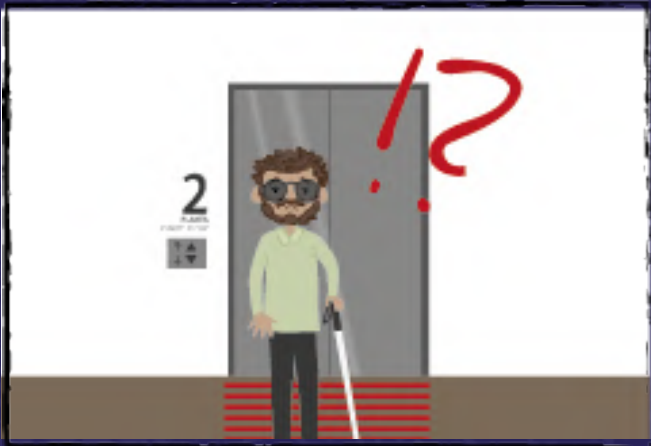
If there is no tactile-visual pavement in front of the elevator, Darek cannot find the door to get off the elevator and go outside.

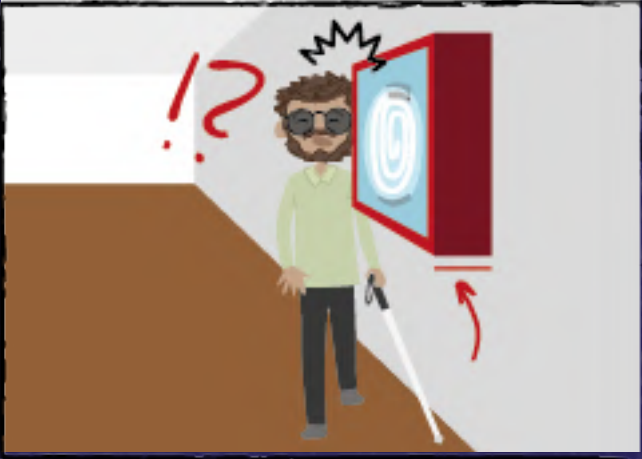
If the fire extinguisher hose box is not embedded in the wall and projects, Darek can hurt himself.
