TRAFFIC SAFETY

Using Engineering to Reduce Accidents

Philip Anthony Gold

INTER-AMERICAN DEVELOPMENT BANK

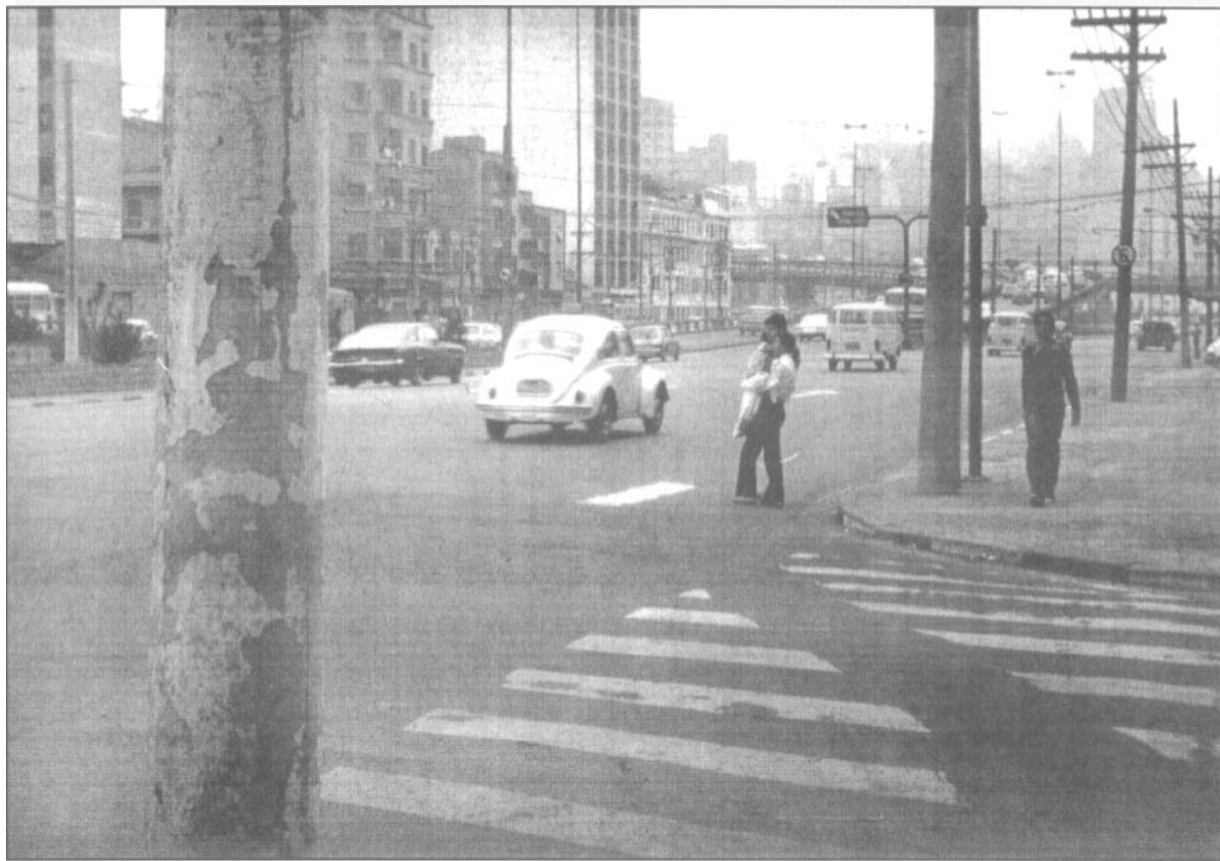
FIGURE 9.24
PEDESTRIANS CROSSING AT EF,
MISLED BY REMAINS OF ROAD MARKING

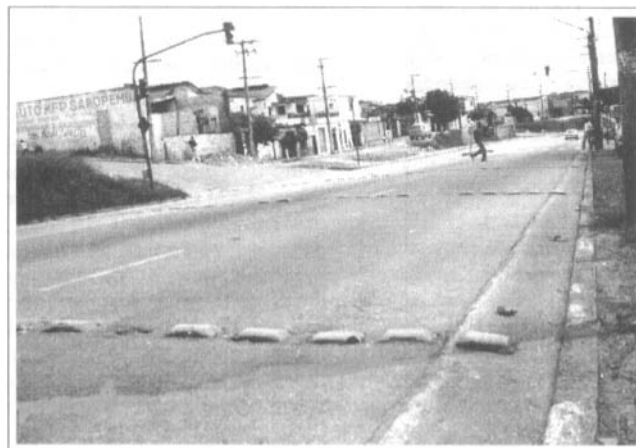
FIGURE 10.3
EXAMPLE OF LOCATION WITH STUDS DAMAGED OR
WRENCHED OUT BY VEHICLES
SAPOPEMBA AVENUE – SÃO PAULO

Transverse stud obstacles have the disadvantage of transmitting noise and vibration beyond the drivers and vehicles that pass over them. They should be avoided in populated areas, since nearby residents may complain or petition for their removal.

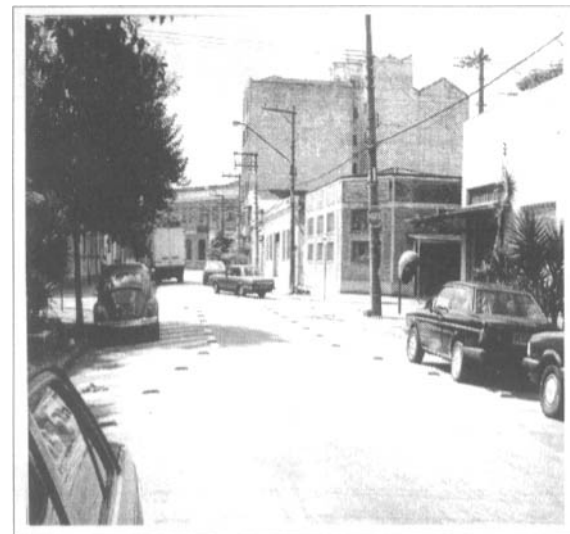
FIGURE 10.32
USE OF STUDS FOR
ROAD NARROWING
