Lessons Learnt from Japan and Latin America and Caribbean Countries in Management of Hazard Resilient Infrastructure

A JICA-IDB Joint Research

TECHNICAL
NOTE N°
IDB-TN-1309

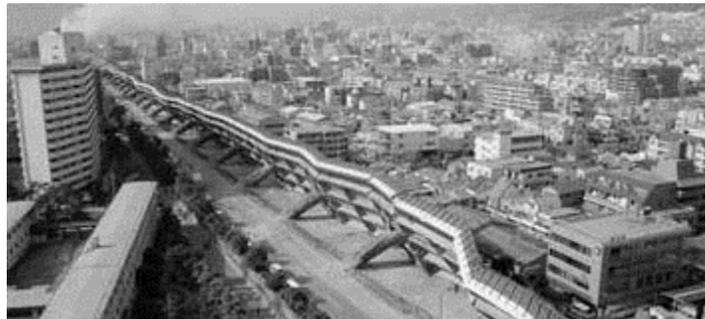
Figure 2-1. Kobe Earthquake. Source: <http://www.bousai.go.jp/>

The Great Hanshin Awaji Earthquake (Kobe Earthquake) occurred in Hyogo Prefecture on January 17, 1995. The earthquake caused over 6,400 casualties and economic losses at US\$85 billion (Cabinet Office 2011). Major railways and highways, including bridges and elevated roads in Kobe City collapsed which impeded relief and rescue operations (Figure 2-1). The full reconstruction of highways took over 1.5 years to complete.

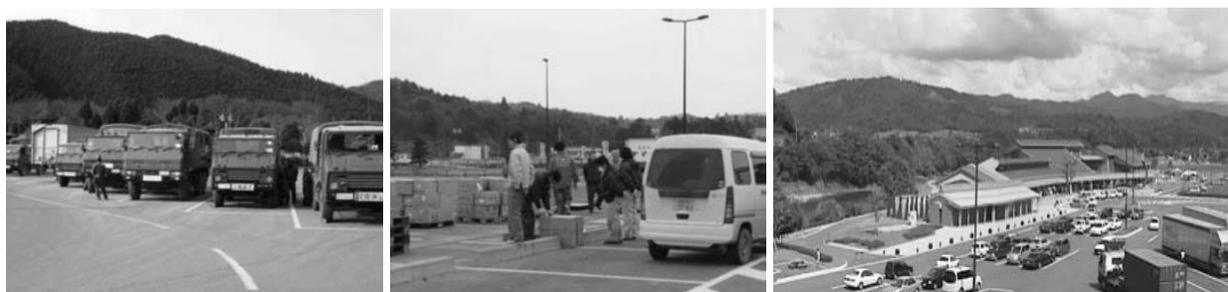
Figure 2-2. Roadside service station, "Michino-eki", during GEJE (left and center) and at normal time (right). Source: MLIT

Prior to GEJE, cost-sharing mechanisms for multi-purpose structures were established between disaster management local offices and road offices in Japan. The disaster management offices cover additional costs for hazard resiliency, such as the cost for raising road heights in road construction.

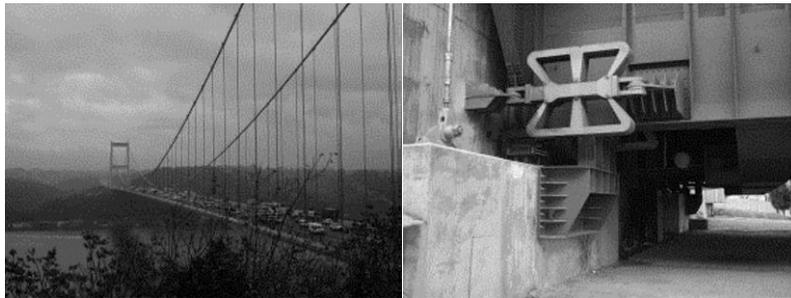
Figure 2-3. Second Bosphorus Bridge and facilities installed. Source: JICA

In this project, piers and other structures were reinforced, and shock absorbers and drop prevention devices were installed (Figure 2-3). This project contributed to mitigating damage and promoting prompt recovery in the event of disasters. Bridges were strengthened to function under the impact of more common earthquakes, which occur at a probability of 50% in 50 years, and avoid serious damage against rarer earthquakes, at probability of 2% in 50 years (Kitayama et al. 2010). In Japan following the Kobe Earthquake, the design concept of bridges was revised. Before the earthquake, bridges were designed to withstand against possible earthquakes during the project's expected life. Revised technical standards improved the structural stability so that

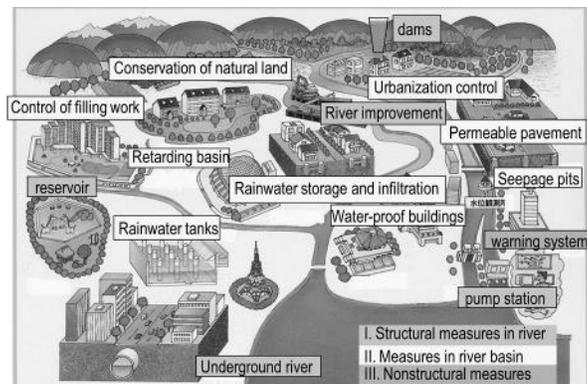
Figure 2-4. Concept of urban flood management, Source: MLIT

The Japanese Government initiated a new approach to urban flood management in 1979. The conventional engineering-oriented approach alone became insufficient to solve serious flood problems caused by rapid urbanization. Historically, Japan had long been conducting flood control works inside the river channels to allow more flood water to flow within the river and to flow out into the sea as quickly as possible. Therefore, Japan started a new approach conducting comprehensive measure interventions in the whole river-basins (not only within the river channels but also for whole river-basin area). The measures include flood risk assessment of the whole river-basins, structural works, such as widening of river channels, various measures distributed in the river basins as shown in figure 2-4, and non-structural measures, such as hazard maps, early warning and evacuation drills. The capacity of retarding floods is increased to reduce flood runoff to the lower stream. This new approach is regarded as the paradigm shift of Japanese flood risk management: “from channel to whole river-basin” (Kundzewicz and Takeuchi 1999).

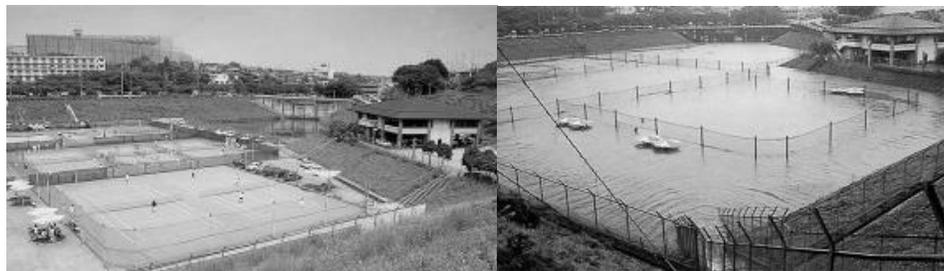
Figure 2-5. Alternative use of retarding pond in urban area. During normal (left) and flooding (right), Source: MLIT

Because it is difficult to acquire lands for ponds or reservoirs in densely developed urban areas, multifunctional facilities are alternatively developed in the river basins. Lands owned by the municipality governments, such as school grounds and sports facilities, have been used for the retarding ponds in case of flooding (Figure 2-5). Local governments, by their ordinances, require private companies and developers to construct retarding ponds to offset run-off volume increased

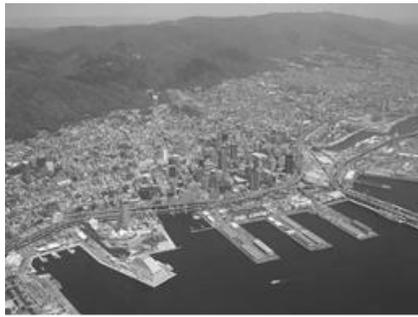
Figure 2-6. Kobe City.

The city, located at the foot of the Rokkosan Mountain Range, has repeatedly suffered from urban floods (Figure 2-6). Urban management in Kobe City is regarded as a good practice, especially in terms of urban flood management adopting the comprehensive flood risk management approach. The approach includes land use regulation, forestation, and structural measures. When Japan started to modernize in the late 19th century, people living in this area had cut down most trees in Rokkosan Mountain Range to use wood for fuel. A forestation program, therefore, was started to mitigate flood risk in 1902, and currently the mountain range is covered by forests. The MLIT and Hyogo Prefecture Government have constructed over 1,000 check (“sabo”) dams to control debris and floods since 1895. Flood damages have shown a constant decrease due to these preventive measures. For instance, 695 people were killed and around 130,000 houses collapsed or were inundated because of urban floods and debris flows in 1938. Damages were significantly lower during the floods of 1967, which caused only 98 deaths and 38,305 collapsed or inundated houses (Rokko Sabo Office 2009).

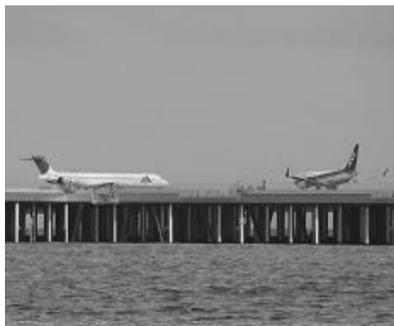
Figure 2-7. Tokyo Haneda Airport in consideration of flood risk mitigation. Source: Ishiwatari M.

The river offices require other organizations to strictly follow the guidelines, including requirements in construction of structures such as dams, barrages, bridges, dykes, pumping stations and gates. Bridges and weirs are constructed in compliance with the minimum requirement of span lengths. For example, construction of the new runway at the Tokyo Haneda Airport at the river mouth of Tamagawa River was subject to careful examination by a MLIT river office for potential risks of disturbing the flood flow of the river. As a result, a bridge-type runway was selected in consideration of flood risk mitigation (Figure 2-7).

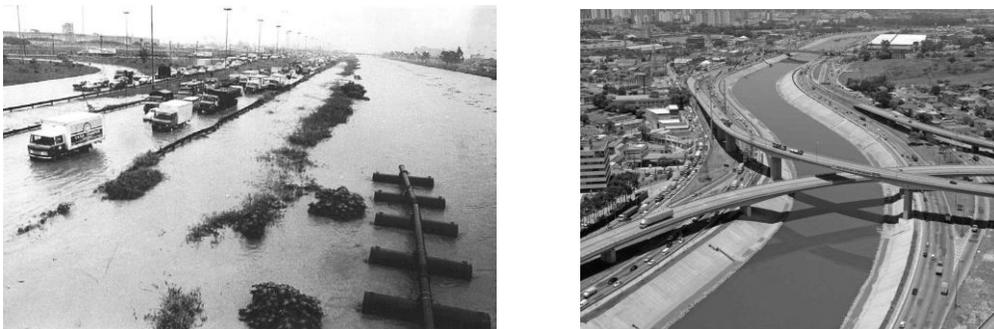
Figure 2-8. Flood in February 1983 and structures constructed after JICA contribution. Source: JICA

JICA financed a flood-capacity improvement work from 1997 to 2006 in the Tietê River Basin (Figure 2-8). Using Japanese experience of river improvement, flood situations were simulated and channel works were designed. The flood capacity of the river was substantially improved from once-in-two year flood to once-in-100 year flood, and flood damage decreased significantly. The economic benefit of avoiding flooding is estimated at US\$108 million per year (JBIC 2008).

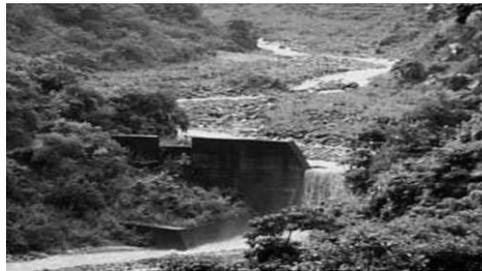
Figure 2-9. Sabo dam in Nepal. Source: JICA

The disaster prevention projects include the construction of soil erosion control ("sabo") dams

upstream of the reservoir (Figure 2-9), the slope protection works for water transfer facilities, the blockage works for the water intake facility, and the monitoring equipment.

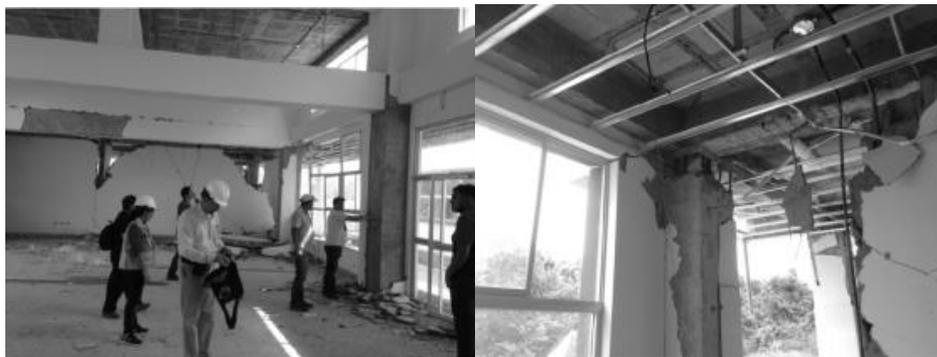
Figure 4.1. Schools damaged by the earthquake: top (two photos): in Pedernales – left (a) shows the most of the damages are the non-structural parts, and right (b) shows a joint damage of this school. Photos: IDB.

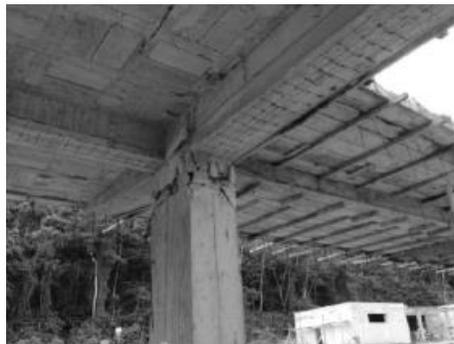
Figure 4.2 Joint damage in the school in La Siberia. This school was under construction when hit the earthquake. Photo: IDB.

La Siberia. This school was still at 60% of its construction progress when the earthquake hit in April 2016. The structure remains, but a joint of the columns and beams was seriously damaged (Figure 4.2). It is supposed that this damage was not only made at the single main shock in April 16 but during the multiple aftershocks after April 16. Applicability of concrete materials was observed as an issue. Cost necessary for repairs was estimated approximately US\$300,000.

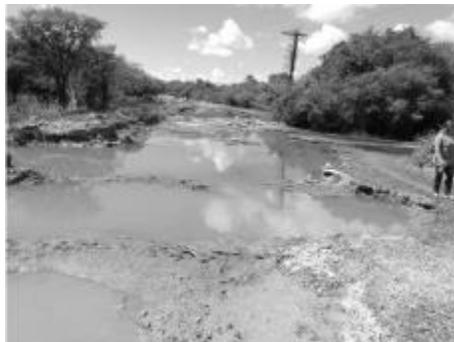
Figure 4.3. The rural path with erosions due to floods. Source: Salvatierra (2016)

Rural path in the Nuevo Puerto Bermejo City, Chaco Province. A road between New Puerto Bermejo City and Old City (and its port) (4.5km) had severe erosions due to heavy rains and floods during December 2015 and February 2016 (Figure 4.3). Nearly 2,500 people, including local citizens and the citizens living in neighbor cities, use this rural path on a daily basis. This path is important for local socioeconomic activities for Paraguay as well. For example, some Paraguay citizens use this path to take advantage of a health facility in Nuevo Puerto Bermejo City. The total cost for the rehabilitation of this path was estimated at US\$1.4 million. In fact, this rural path had been repaired twice before; after the ENSO related floods in 1983 and in 1992. This third repair was realized with the financial resources of the AR-L1045 loan, however, the focus of these financial resources is just for repairs, additional investment would be necessary to protect from future floods under the concept of “build back better” (Salvatierra, 2016).

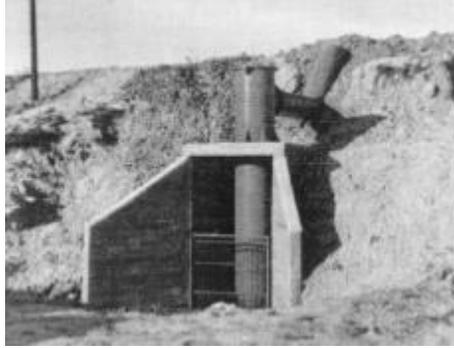
Figure 4.4. Flood control facility (water pump station) constructed just after the 1997-97 ENSO floods.
Source: Salvatierra (2016)

Water control and pumping facility in Las Palmas – La Leonesa, Chaco Province (in Argentina). This flood control infrastructure was constructed just after the 1997-98 ENSO flood (Figure 4.4). The components of this infrastructure include water pumping stations, river defense walls along with the Paraguay River, and drainage networks for inland water control. The water pumping stations (Figure 4.5) did not work correctly during the 2015-2016 ENSO. River defense walls and drainage networks were also damaged. As a result, Las Palmas and La Leonesa, with a total 2,500 population located in the river basin, were affected by floods. In fact, after the installation of this infrastructure (after the 1997-98 ENSO floods), this area was affected by droughts for a long time. At that time, the local government gave high priority to protect the citizens from drought impact, which meant that flood control was temporary a low priority and minimal maintenance was made for many years. As a result, the infrastructure was not effective during the ENSO rainy season of 2015-2016, causing severe floods in the area.

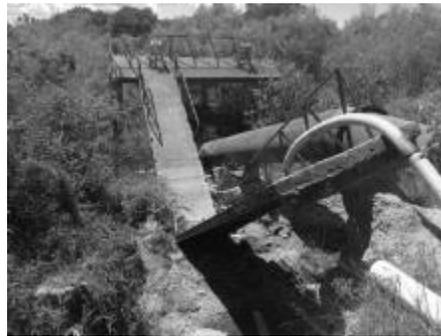
Figure 4.5. Flood control facility damaged during 2015-2016 ENSO. Source: Salvatierra (2016)

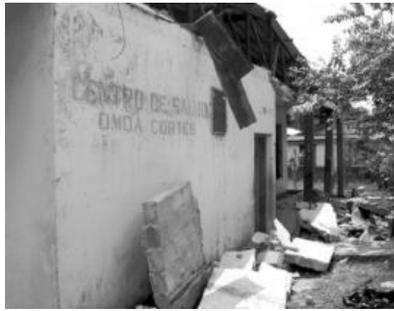
Figure 4.6. A clinic located in Municipality of Omoa. Photo: La Prensa.

The Municipality of Omoa (in the Department of Cortés) was seriously damaged due to the 2009 earthquake (La Prensa, 2009). Copeco (Comisión Permanente de Contingencias) reported severe damage observed in basic infrastructure of this region including housing, schools, catholic churches, clinics (Figure 4.6), and court house buildings (La Prensa, 2009). Within these damaged infrastructure, a clinic and the court house were financed through the Program HO0109. These facilities’ perimeter and building walls were seriously damaged. Additionally, outside of Omoa there were additional 11 court house buildings for justice of peace across the country that suffered similar damages to the perimeter and building walls, roofs, aqueducts and metallic doors (CJPJH, 2015). These damages were repaired during 2014 – 2015. The total repair cost was more than US\$12 million (CJPJH, 2015).

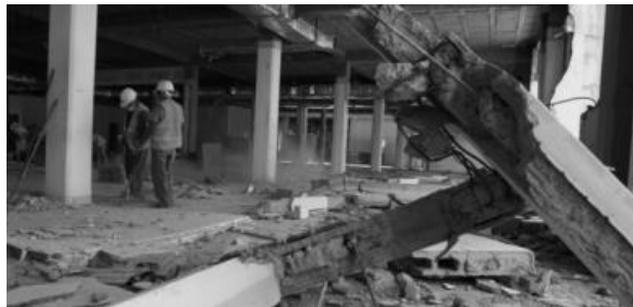
Figure 4.7. Damaged Building of Supreme Court in San Pedro Sula. Photo: HRN La Voz de Honduras

One of the infrastructures that was severely damaged was the Supreme Court building of San Pedro Sula (Figure 4.7)¹⁸. The damages in this specific case were caused by soft soil and reclaimed land (Luna, 2010). Soft soils amplify ground shaking so that buildings on soft soils tend to be damaged or destroyed easily (USGS, 2016). The Court building, a reinforced three-story concrete frame, was constructed on 3m depth of soft soil without ground-strengthening or building foundation strengthening measures. In contrast, a multi-story reinforced concrete stadium located less than a half mile away constructed on strengthened ground experienced only minor damages (Luna, 2010). This experience illustrates the importance of soil analysis and the implementation of strengthening measures to reduce earthquake risk.

An additional cause of the Court building damages was due to its insufficient structural design; damages were observed in walls made by concrete frames in-filled with brick masonry (Luna, 2010). This in-filled wall design had a small separation between the column and the in-fill, which caused weakness of the building and evolved in small gaps which led to the structure's failure (referred to as "short-column effect"). This is a well-known problem, but is often ignored in practice (Luna, 2010). The Court building in San Pedro Sula was finally reconstructed with anti-seismic technology and re-opened in 2015 with a total cost of US\$6 million.

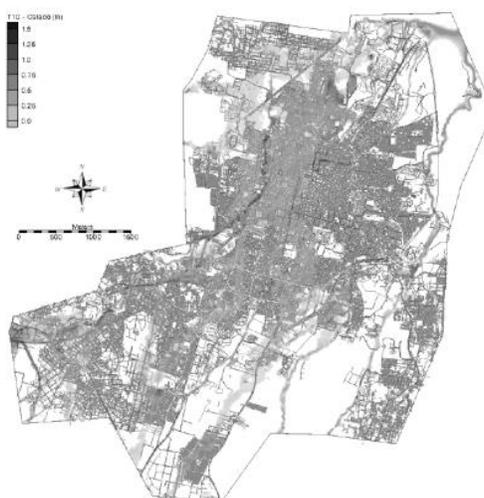
Figure 4.8. Flood hazard map (probability of once 10 years). Source: BID (2012b).

Prior to the Plan, the IDB developed a technical study to identify probable local flood areas and its eventual socioeconomic impact (IDB, 2012b). According to the study, more than 20,000 citizens will be affected even due to a high frequent flood (once every 10 years’ probability, Figure 4.8). On these bases, the Action Plan recommended the two lines of actions for flood risk

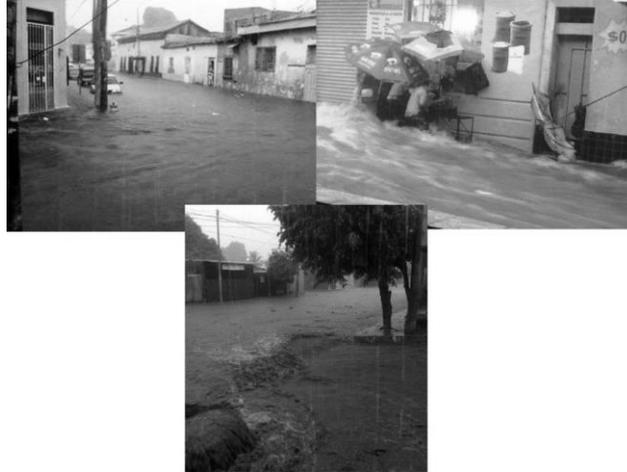
Figure 4.9. Floods in September 2014 in Santa Ana. Source: Elsalvador.com (2014)
Points to be discussed

Another flood occurred in September 2014, four months after the flood in May (Figure 4.9). The Ministry of Environment and Natural Resources (MARN) recorded a precipitation of 46 millimeters/hour in the urban area (La Página, 2014). The flood was caused not by the volume of the precipitation, but the malfunctioning the drainage system, which experienced reduced performance due to the illegal dumping (La Prensa, 2014). 14 vehicles were damaged and several citizens had to be evacuated (Redhum, 2014).
